**SELF-LUBRICATING COMPOSITE  
BEARING MATERIALS — PART II: CORROSION  
PREVENTIVE SOLID LUBRICATION OF THE  
ASALM MISSILE HYDRAULIC  
ACTUATOR BEARINGS**

HUGHES AIRCRAFT COMPANY  
Culver City, California 90230

December 1979  
TECHNICAL REPORT AFML-TR-79-4091, Part II  
Final Report for Period 1 June 1978 to 15 May 1979

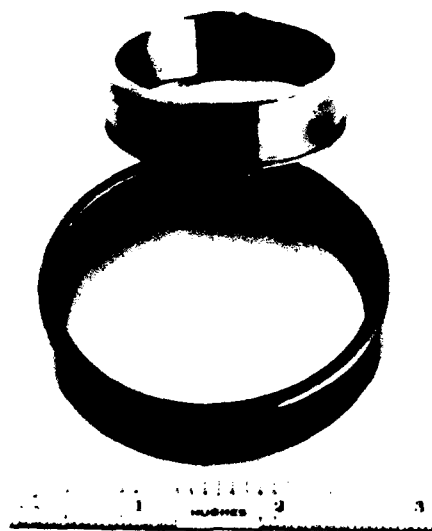
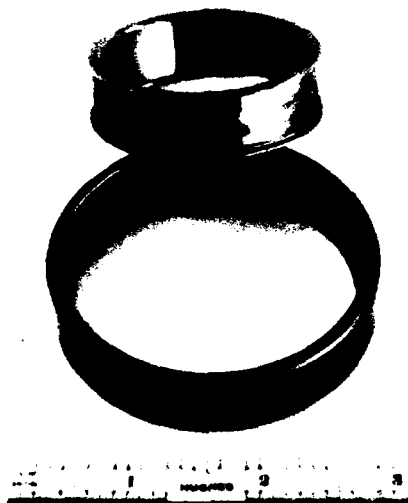
BEARING  
3

BEARING  
4

BEARING  
10

BEARING  
11

BRG 4 - 4R-54288  
5 - 4R-54289  
10 - 4R-54290-1  
11 - 4R-54290

spallation similar to that seen in the cleaned bearings (Numbers 8 and 9 in Figure 13). There is no operational need to run-in the sputter lubricated bearings here, as there is no transfer film to establish and any torque reduction on run-in is inconsequential. They were run-in here only to provide a pre-test conditioning equivalent to that of the composite roller run-in bearings. Such run-in may in fact reduce the operational life time of solid lubricant sputtered bearings, especially in the case of marginal adhesion of the solid lube film.

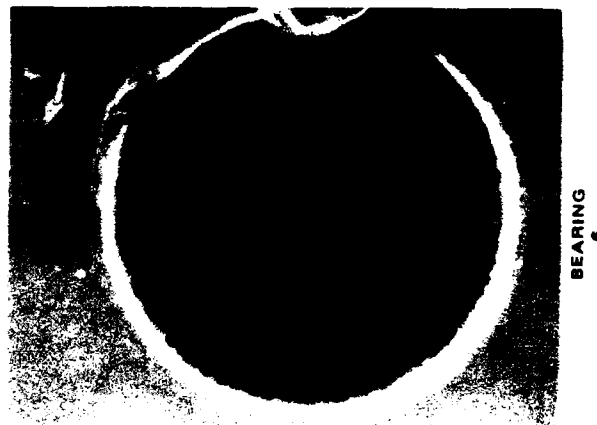
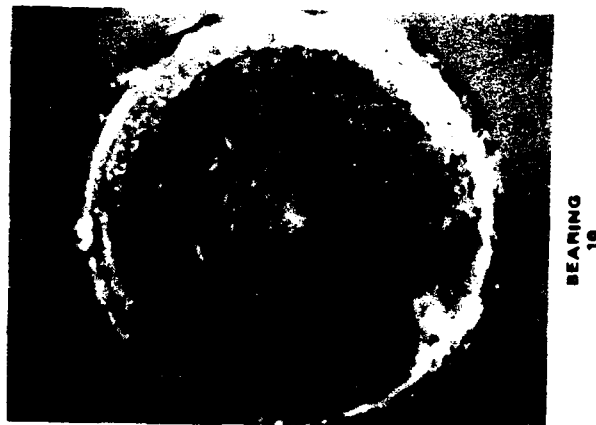
Figure 23. Appearance of used rollers following 24 hour 100% relative humidity testing, 15X magnification.

Flowering corrosion was observed on rollers removed from bearings 6 and 10 but not on rollers removed from No. 5 as illustrated in Figure 23. The corrosion was always found along the roller face circumference, the same area as to where the metal-to-metal contact occurs, resulting in roller damage. Evidence of corrosion on bearing 6 is disturbing as that bearing had not been subjected to testing under load; even the degreasing procedure was

done with the bearing disassembled. Thus either the NiCr-TiC handcoat is of itself porous and/or fractured prior to testing or it was easily removed by rotating the bearing by hand with no load, in the grease-lubricated condition. In view of the large amounts of NiCr-TiC removed from bearings 8 and 9 during cleaning, the latter case is not unreasonable.
